ANTIGUA MARINE
SURVEY & CONSULTING, INC

REPORT OF MARINE SURVEY OF THE VESSEL

1990 Catalina 42

CONDUCTED ON
August 28, 2009

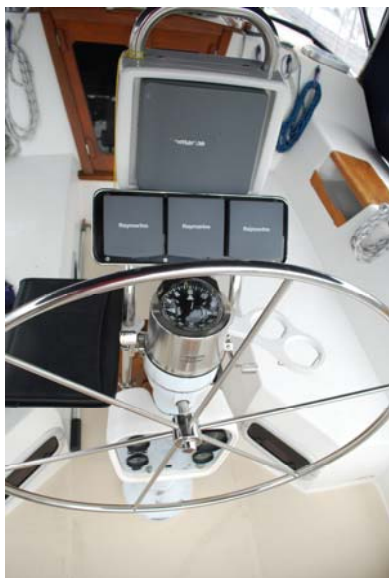
Throttle control at helm.

8. Windex at mast head missing port tacking angle square. (page 17)
9. Throttle controls operated but transmission lever stiff. (page 18)
10. Recommend placing partner wedges where mast passes through deck opening. (page 20)
